ACCELERATED CREEP TESTING OF NEW CREEP RESISTING WELD METALS

Stan T. Mandziej,¹ Anna Výrostková,² Mojca Šolar³

Keywords: P91 welds, accelerated creep tests, microstructure, Gleeble

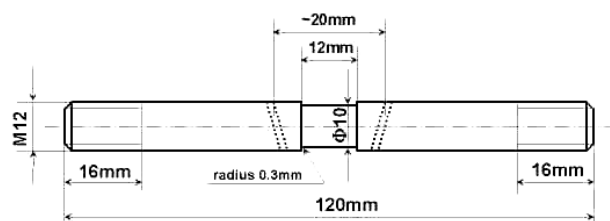
ACT sample for testing of all weld metal

Figure 2: Cross-weld samples used for ACT on all-weld-metal and on weld's HAZ in the "SmartWeld" EU project

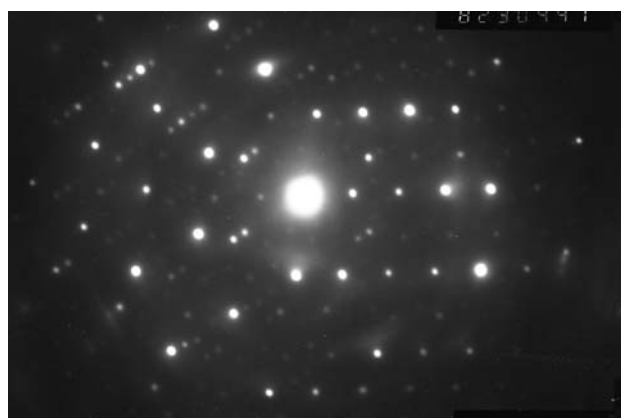
Figure 42: Diffraction from carbides of Figure 41, with double-diffraction effects
